本書には、以下に示す誤りがございました。お詫びして訂正いたします。

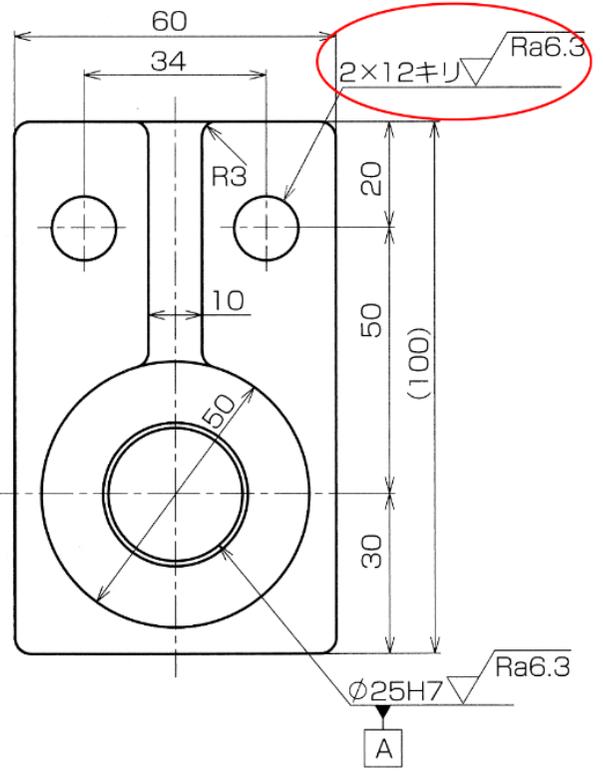
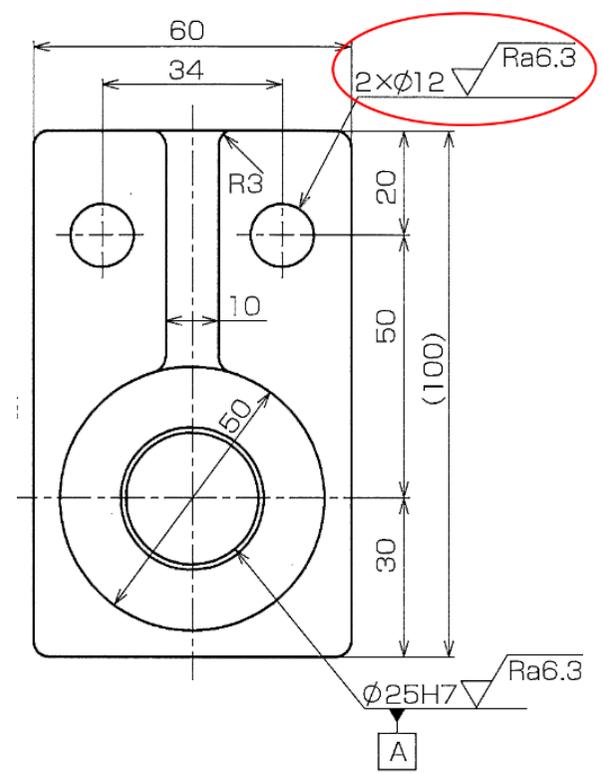
箇所	誤	正
製図例3-12 右 ⑯

<p>Technical drawing of a part with two holes. Dimensions: 60 (total width), 34 (hole spacing), 20 (hole diameter), 10 (hole offset), 50 (neck length), 30 (bottom hole diameter), 100 (total height), 50 (bottom hole diameter). Surface finish: Ra6.3. Hole specification: 2×12\neqU. Section A-A is indicated.</p>

<p>Technical drawing of the same part. Dimensions are identical to the error drawing. Hole specification: 2×ϕ12. Surface finish: Ra6.3. Section A-A is indicated.</p>
製図例3-13 左 ⑰

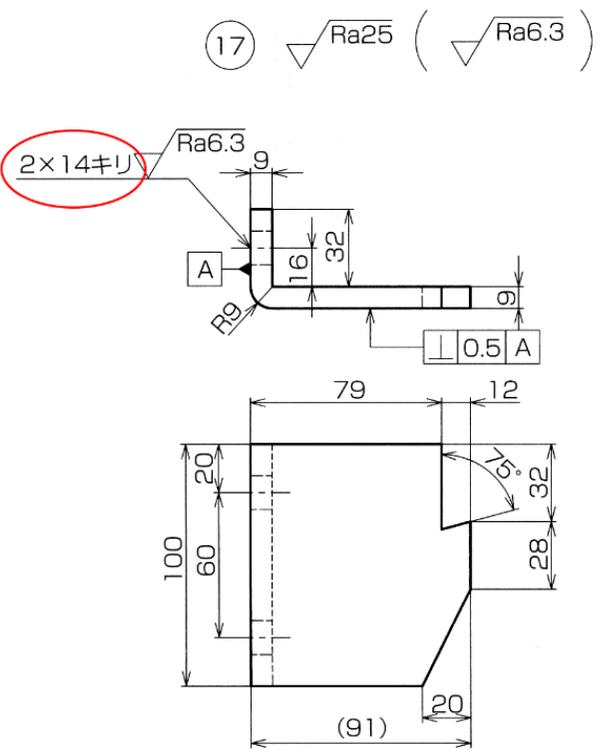
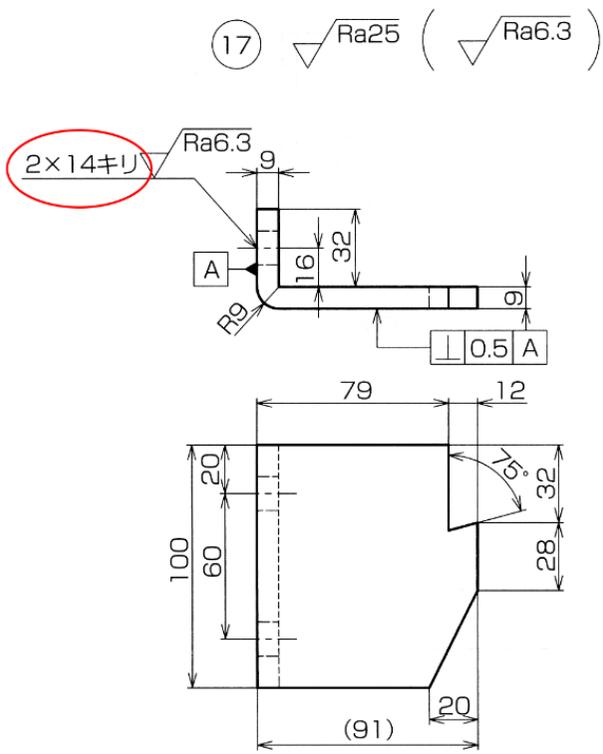
<p>Technical drawing of a part with a chamfered edge. Dimensions: 79 (total width), 12 (chamfer width), 100 (total height), 60 (height to chamfer), 20 (chamfer height), 28 (chamfer offset), 32 (chamfer length), 9 (chamfer thickness), 16 (chamfer radius), 9 (chamfer radius), 0.5 (chamfer tolerance). Surface finish: Ra6.3. Chamfer specification: 2×14\neqU. Section A-A is indicated.</p>

<p>Technical drawing of the same part. Dimensions are identical to the error drawing. Chamfer specification: 2×14\neqU. Surface finish: Ra6.3. Section A-A is indicated.</p>
